**Re: NPDES Phase II – Year 17 Annual Report
Libertyville Township MS4
Permit No. ILR40-0077**

Division of Water Pollution Control ANNUAL FACILITY INSPECTION REPORT

for NPDES Permit for Storm Water Discharges from Separate Storm Sewer Systems (MS4)

Report Period: From March, 2019 To March, 2020

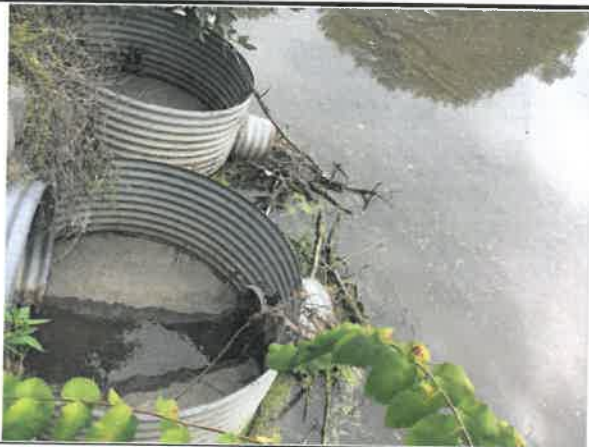
Trickle observed at northerly most inlet, debris obstructing entrance of all inlets

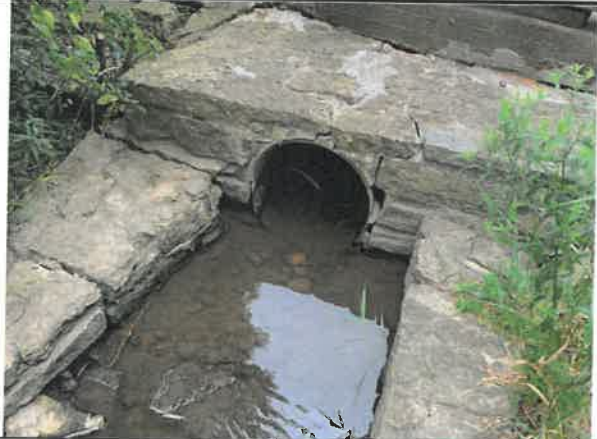
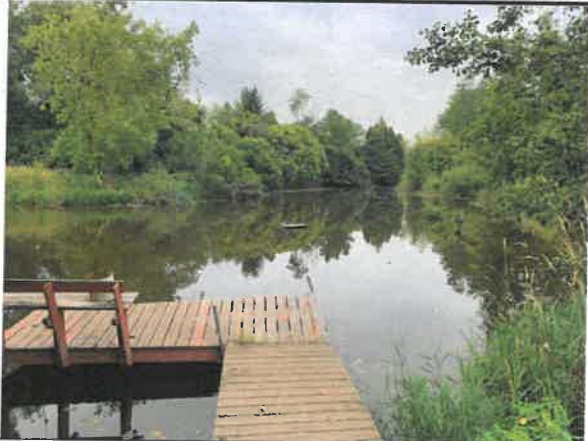
<p>Outfall discharging into the basin. The outfall is in poor condition and sediment was observed in and outside of the outfall.</p>	<p>Overall view of the basin. Weeds present around the entirety of the basin. No other major issues observed.</p>

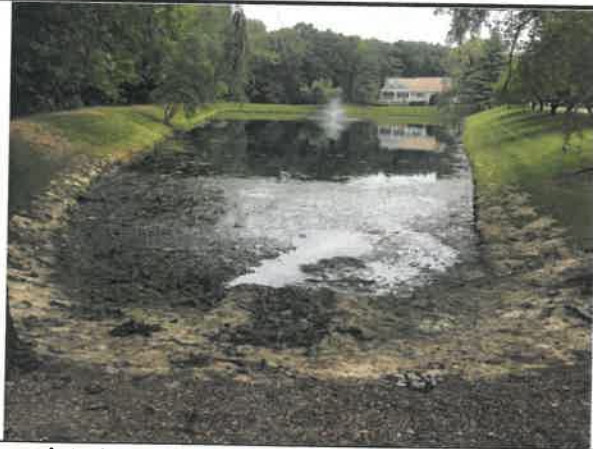
Accumulated sediment/ debris in storm inlet pipes on southerly side of basin
