**Re: NPDES Phase II – Year 17 Annual Report
Libertyville Township MS4
Permit No. ILR40-0077**

Division of Water Pollution Control ANNUAL FACILITY INSPECTION REPORT

for NPDES Permit for Storm Water Discharges from Separate Storm Sewer Systems (MS4)

Report Period: From March, 2019 To March, 2020

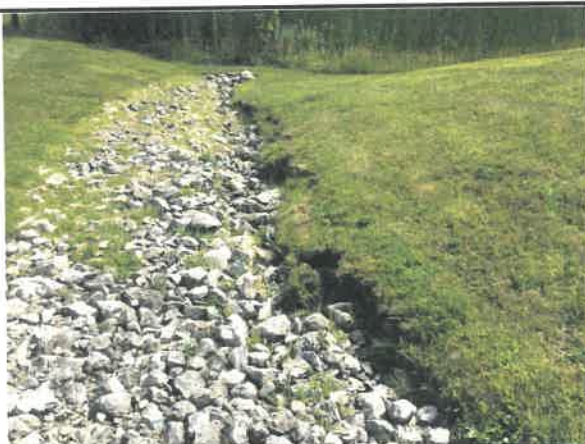
Additional comments:
Side of trench eroding away

Side of trench eroding away

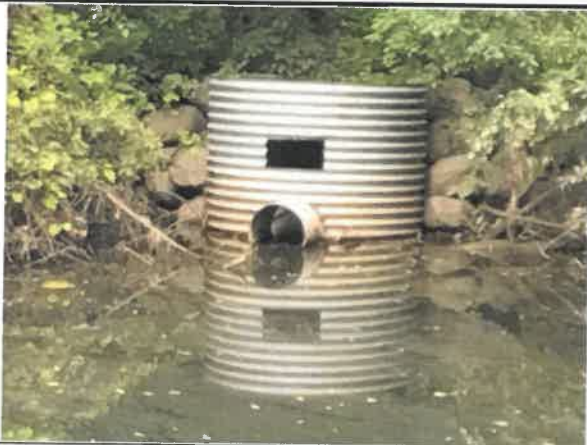
Heavy vegetation surrounding outfall

Easterly view of outfall structure looking westerly

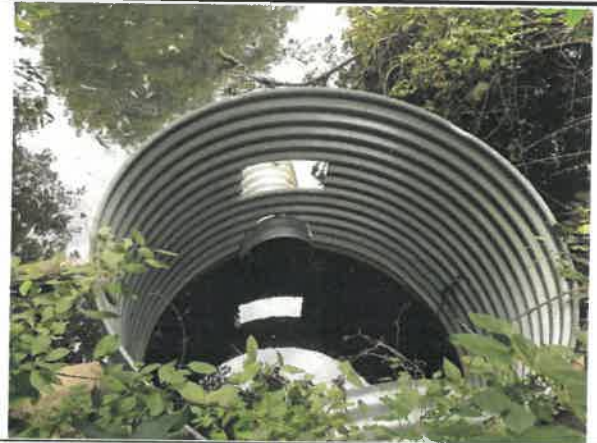
View into outfall structure

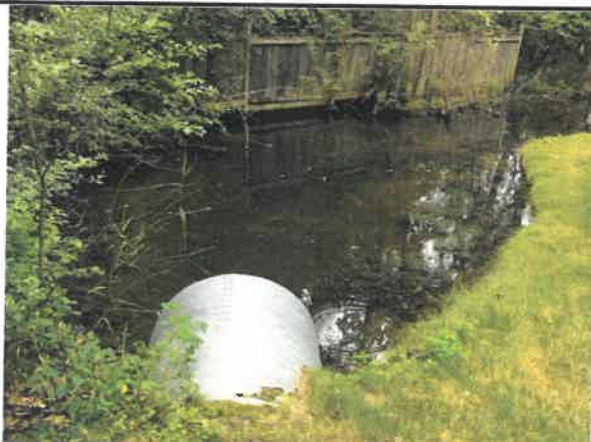
Easterly view of outfall structure looking westerly at release side of structure

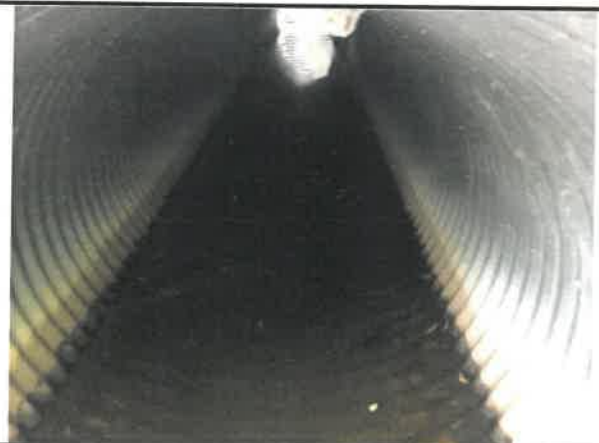
View into structure

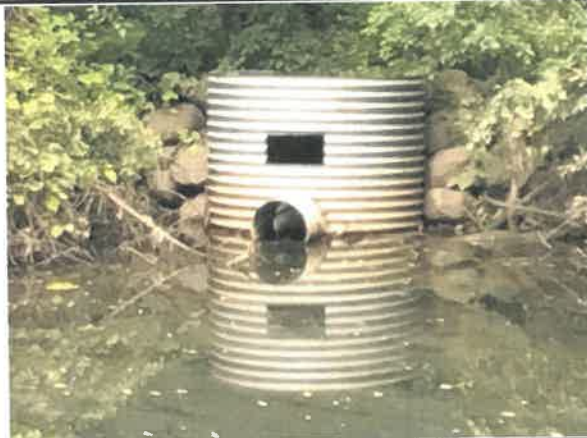
Additional comments:
Heavy vegetation surrounding outfall

Easterly view of outfall structure looking westerly

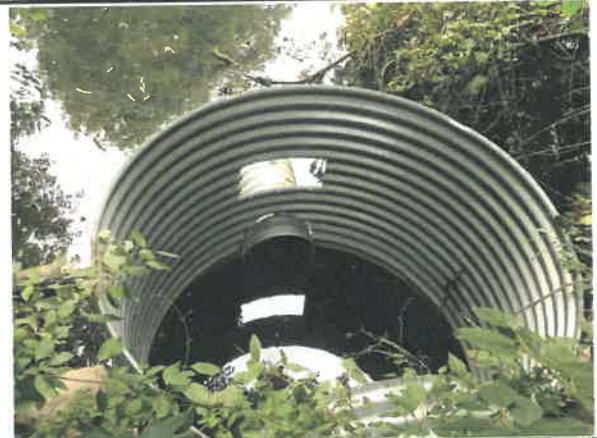
View into outfall structure

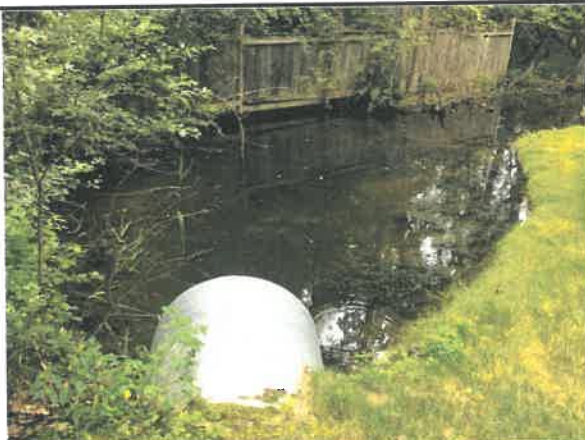
Easterly view of outfall structure looking westerly at release side of structure

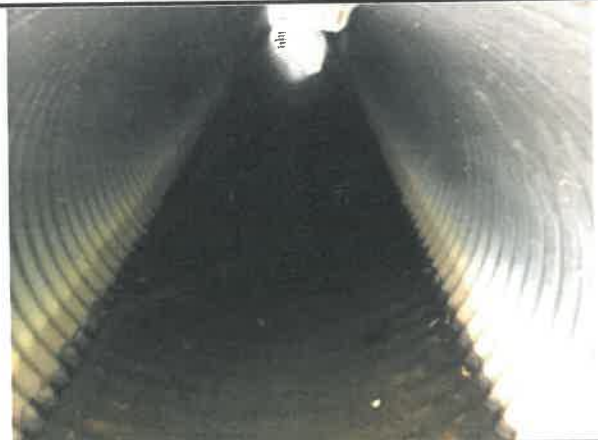
View into structure

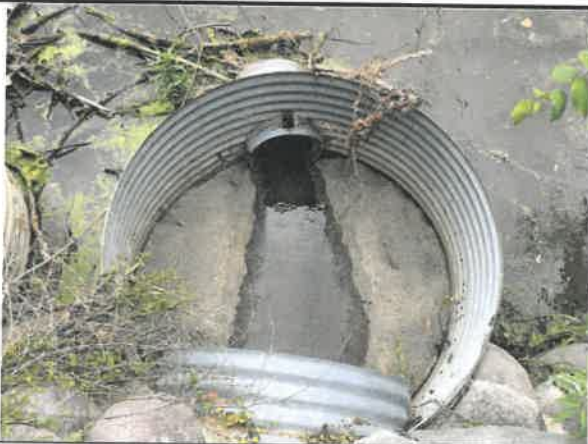
Trickle observed at northerly most inlet, debris obstructing entrance of all inlets

View looking down onto outfall

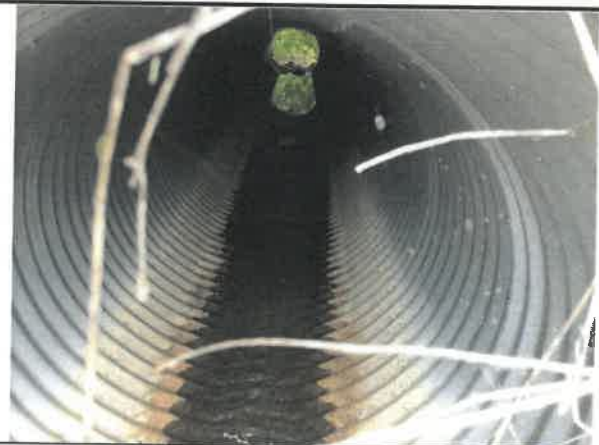
View into outfall

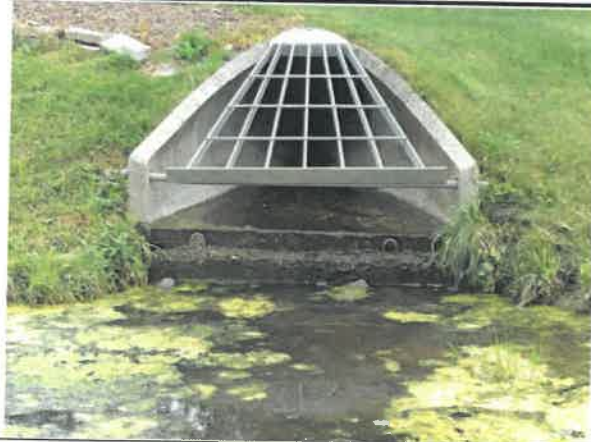
Additional comments:
Minor algae growth in outfall structure

View looking into outfall structure

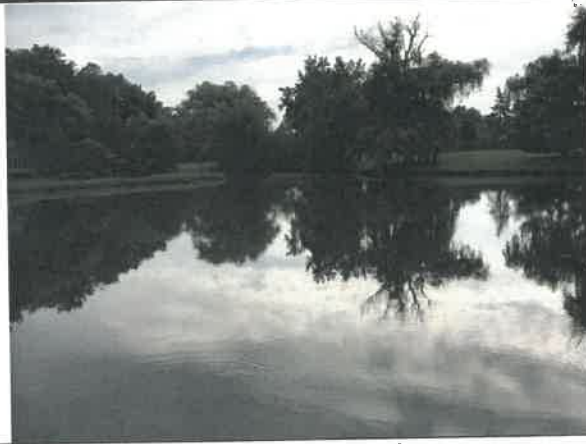
Accumulated debris located at outfall inlet structure, pool clarity poor, no vegetation observed substantial sediment observed

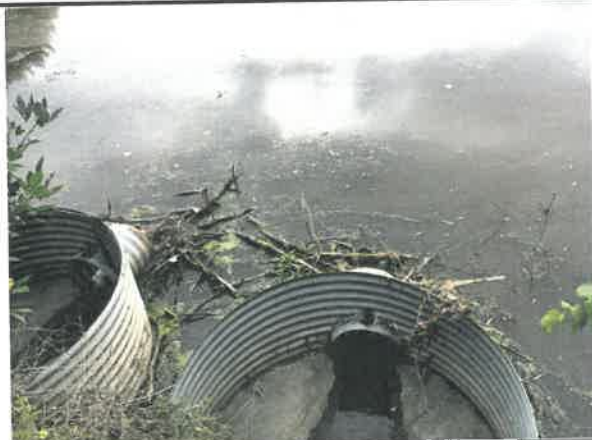
Accumulated debris at outfall structure

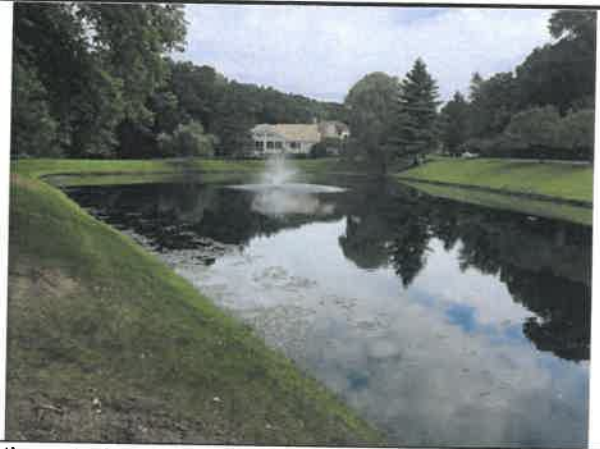
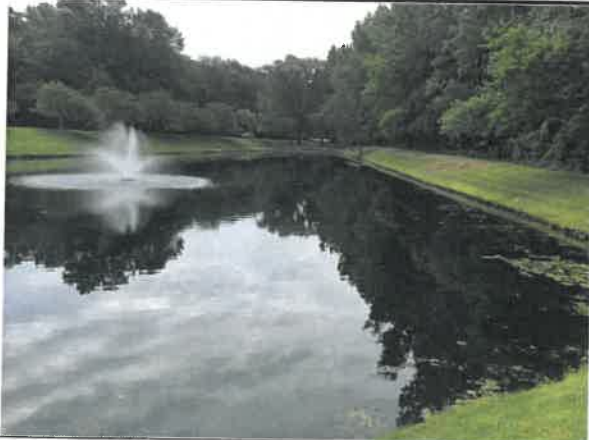
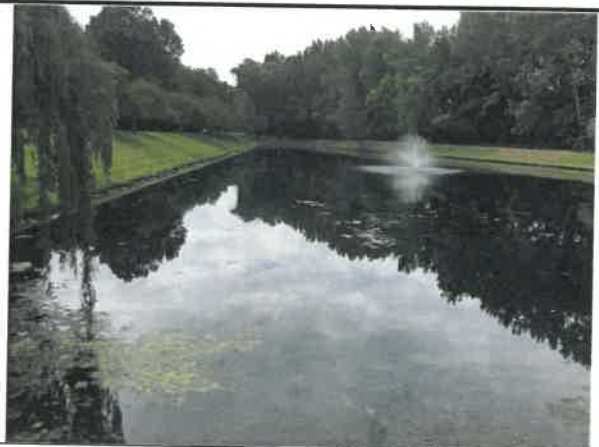
Additional comments:
Heavy debris on southerly side of basin, clean out maintenance recommended

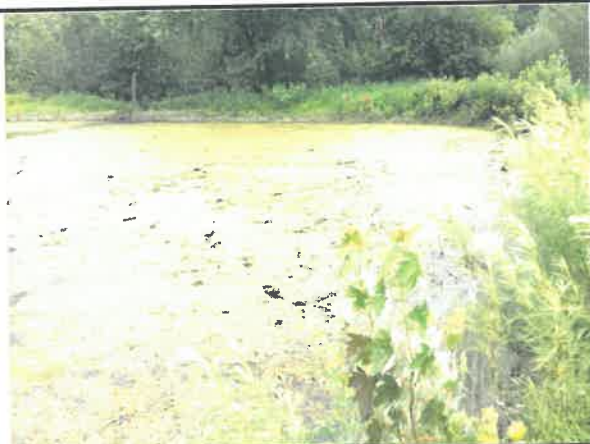
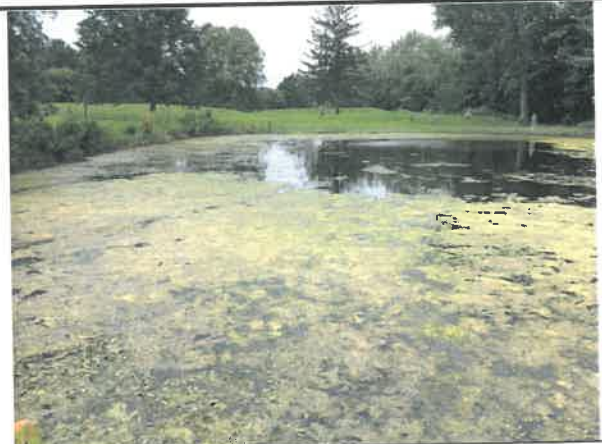
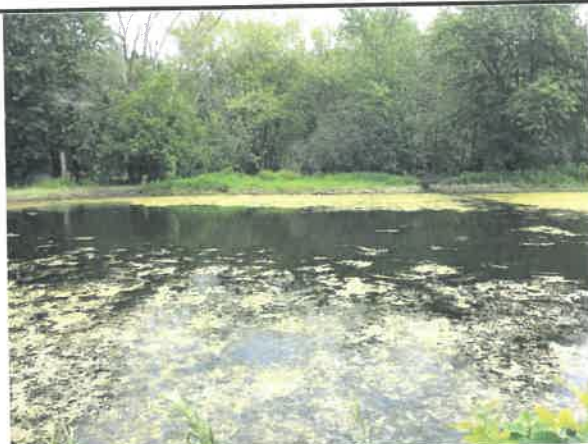
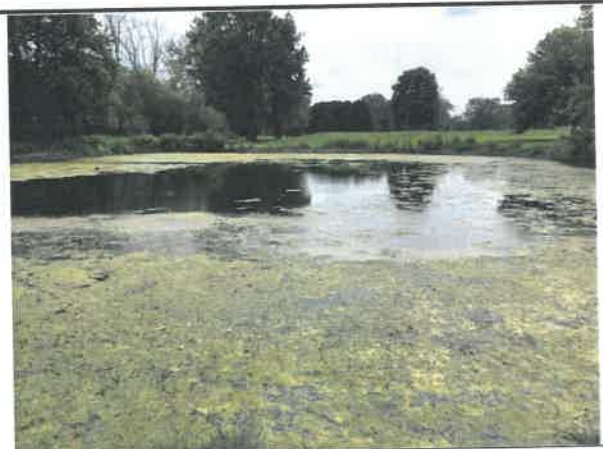
Additional comments:
Algae growth covering approximately 60% of water surface

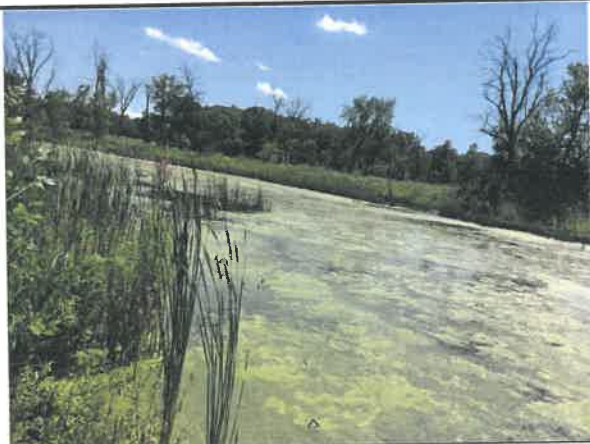
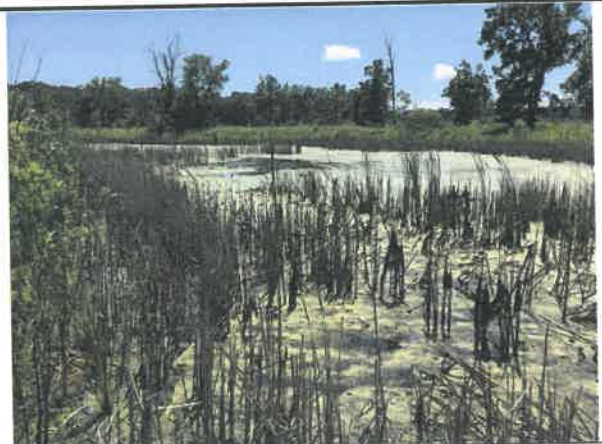
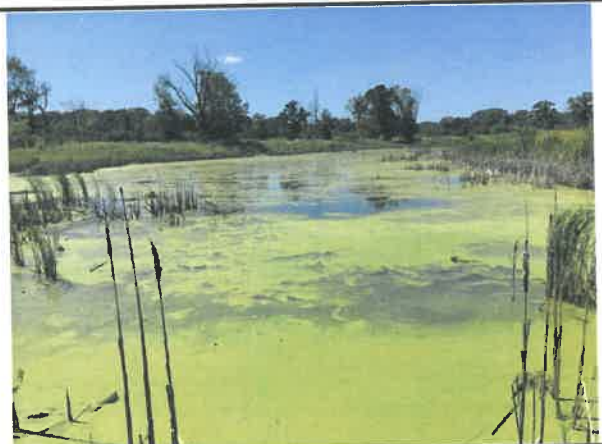
Trash or Debris Accumulated in Basin?	No	Visual Evidence of Oil, Gasoline, Contaminates or Other Pollutants?	No	Visual Evidence of Dumping?	No
Invasive or Nuisance Weeds Present?	Yes	Signs of Erosion, Staining, Damage or Obstructions at Inlets/Outlets?	No	Erosion on Side Slopes?	No
Sediment Accumulated in Basin?	No	Rock Missing Around Inlets, Outlets or Spillways?	No	Excessive Algae Present?	Yes
Evidence of Fish Kill?	No	Trash or Debris Plugging Openings in Trash Rack?	No	Maintenance Needed in Basin?	No

Additional comments:
Green algae coverage, heavily vegetated area

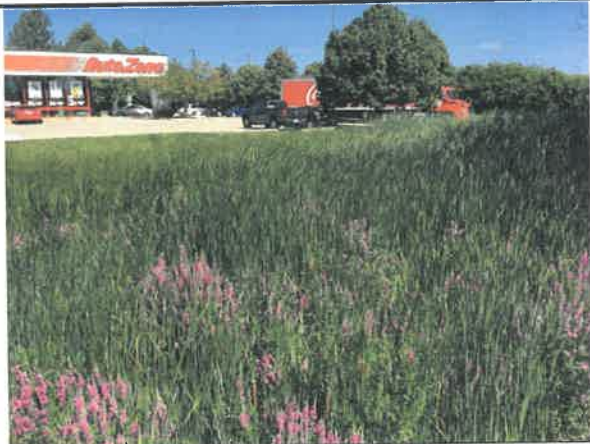
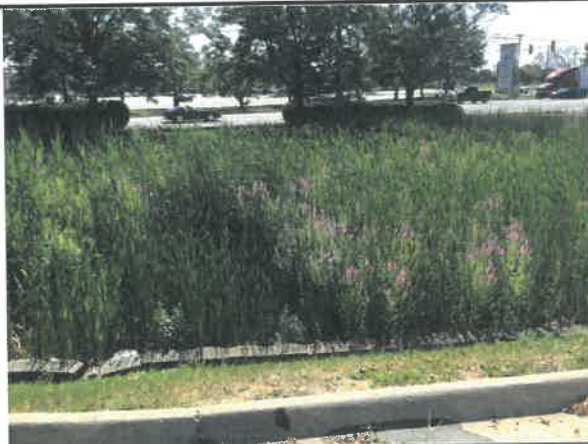
Trash or Debris Accumulated in Basin?	No	Visual Evidence of Oil, Gasoline, Contaminates or Other Pollutants?	No	Visual Evidence of Dumping?	No
Invasive or Nuisance Weeds Present?	Yes	Signs of Erosion, Staining, Damage or Obstructions at Inlets/Outlets?	No	Erosion on Side Slopes?	No
Sediment Accumulated in Basin?	No	Rock Missing Around Inlets, Outlets or Spillways?	No	Excessive Algae Present?	No
Evidence of Fish Kill?	No	Trash or Debris Plugging Openings in Trash Rack?	No	Maintenance Needed in Basin?	No

Additional comments:
Excessive quality of cattail vegetation

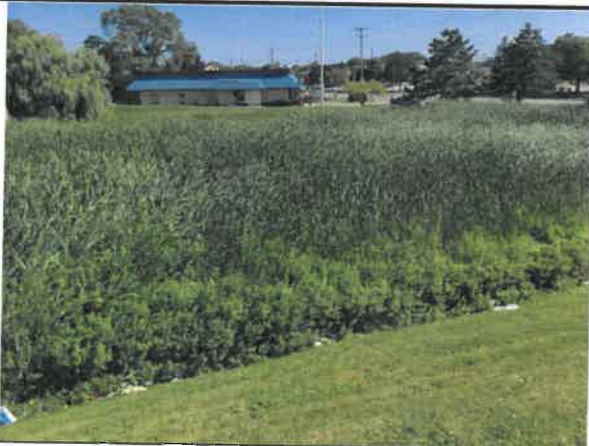
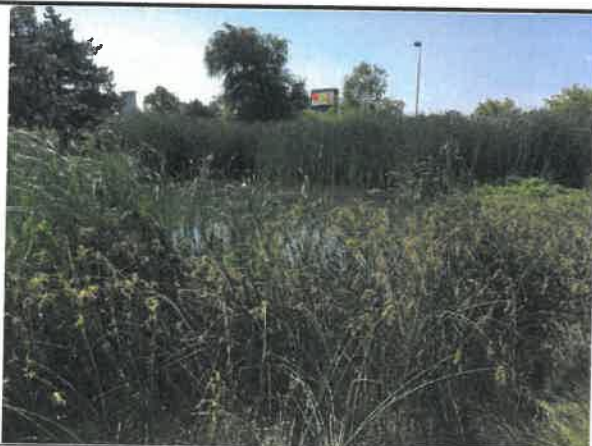
Trash or Debris Accumulated in Basin?	No	Visual Evidence of Oil, Gasoline, Contaminates or Other Pollutants?	No	Visual Evidence of Dumping?	No
Invasive or Nuisance Weeds Present?	Yes	Signs of Erosion, Staining, Damage or Obstructions at Inlets/Outlets?	No	Erosion on Side Slopes?	No
Sediment Accumulated in Basin?	No	Rock Missing Around Inlets, Outlets or Spillways?	No	Excessive Algae Present?	No
Evidence of Fish Kill?	No	Trash or Debris Plugging Openings in Trash Rack?	No	Maintenance Needed in Basin?	No

Additional comments:
Excessive quality of cattail vegetation
