**Re: NPDES Phase II – Year 17 Annual Report
Libertyville Township MS4
Permit No. ILR40-0077**

Division of Water Pollution Control ANNUAL FACILITY INSPECTION REPORT

for NPDES Permit for Storm Water Discharges from Separate Storm Sewer Systems (MS4)

Report Period: From March, 2019 To March, 2020

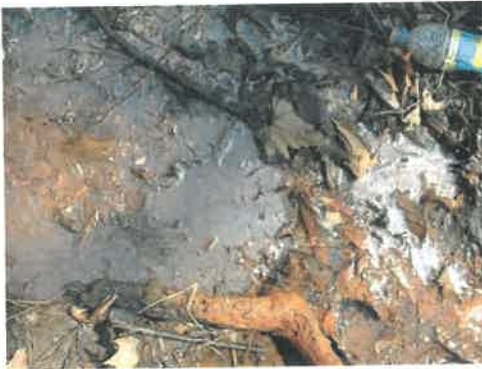
Natural sheen from bacteria forms a swirl-like film that cracks if disturbed.

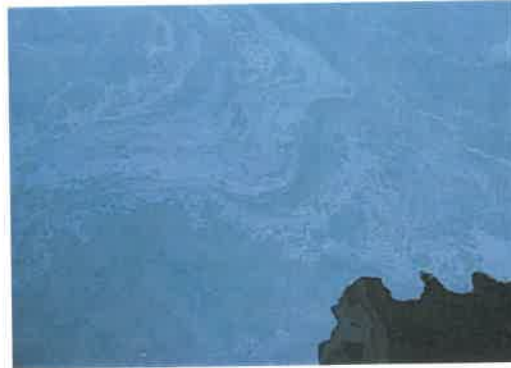
Synthetic oil forms a swirling pattern.

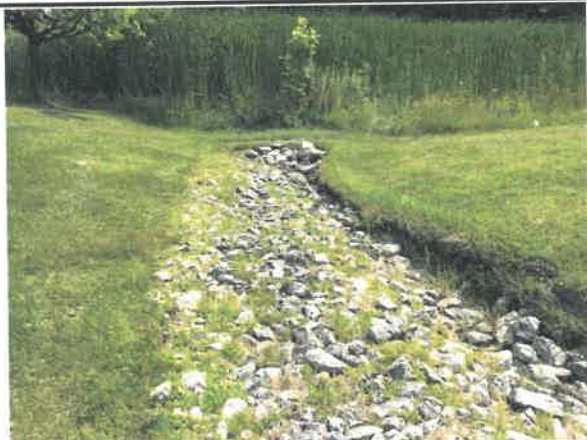
Additional comments:
Side of trench eroding away

Southerly view of trench

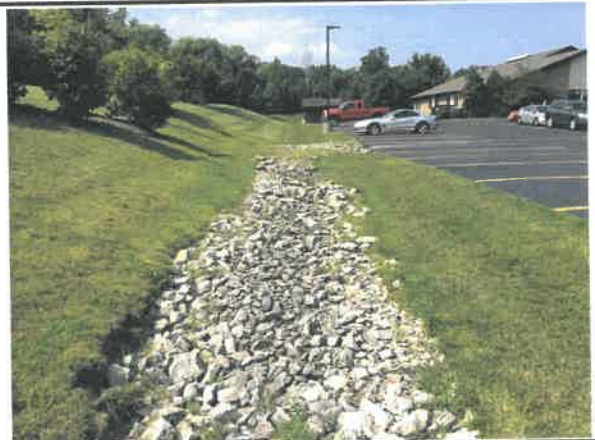
Northerly view of trench

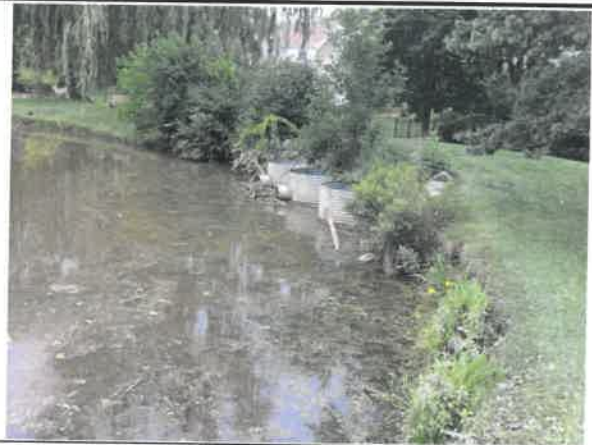
Trickle observed at northerly most inlet, debris obstructing entrance of all inlets

Northeastern side of outfall looking southwesterly

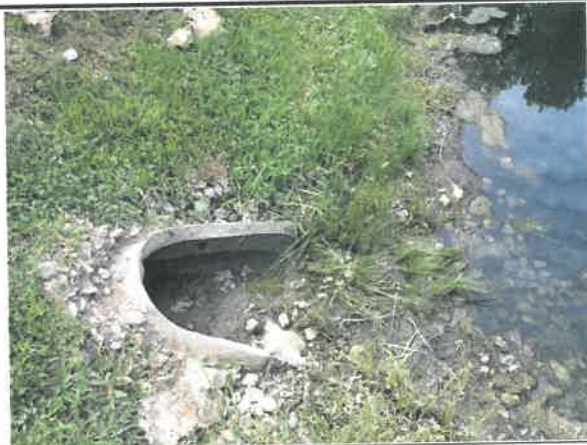
Additional comments:
Missing metal trash grate

Profile view of FES

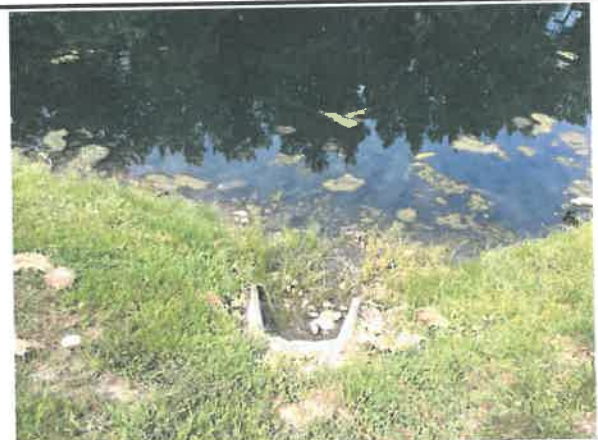
Top view of FES

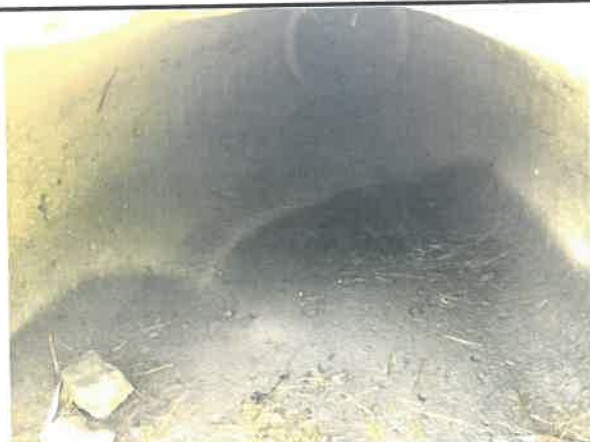
View looking into FES

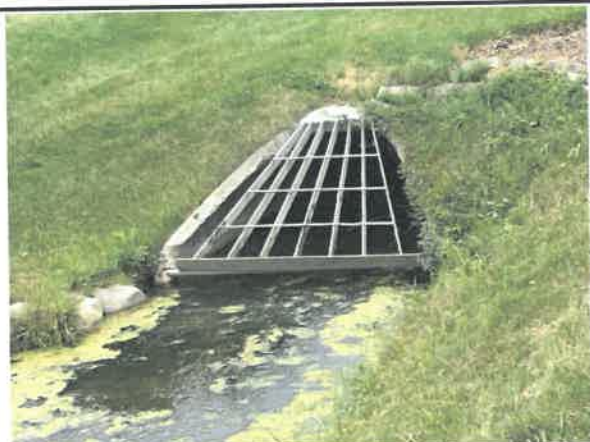
Heavy algae surrounding outfall at opening, submerged in approximately 6-inches of water

View into FES

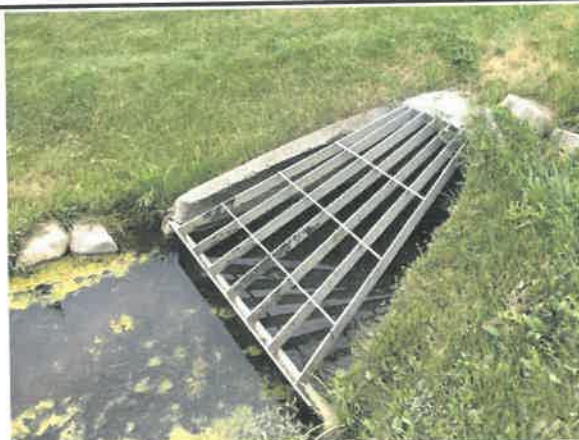
Profile view of FES

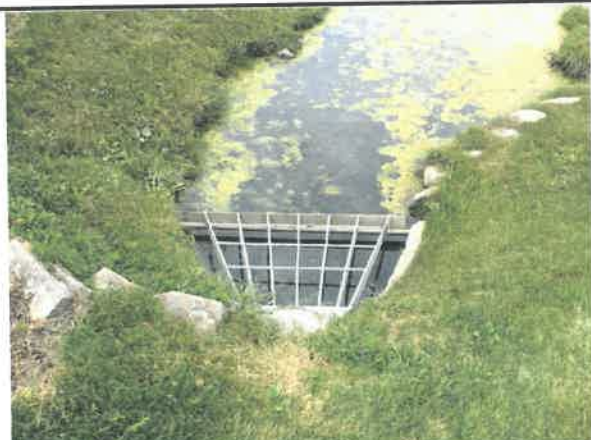
Top view of FES

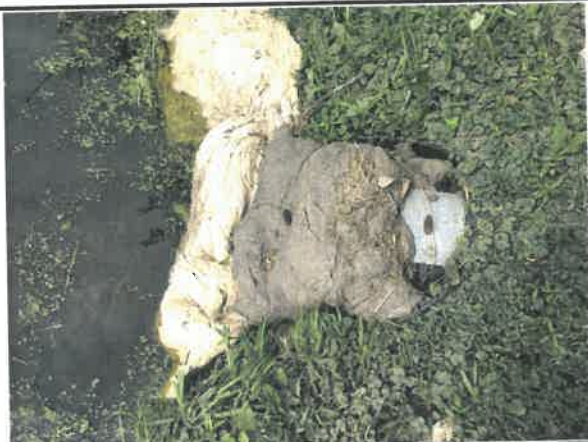
*Revised per ATL revision: outfall is not submerged, it is covered with debris.

Completely sedimented due to wildlife

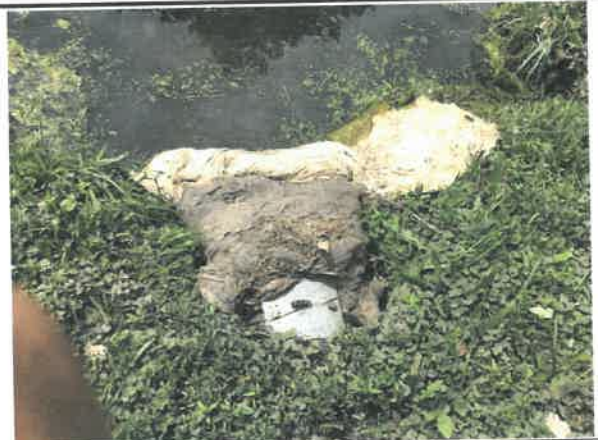
Completely sedimented due to wildlife

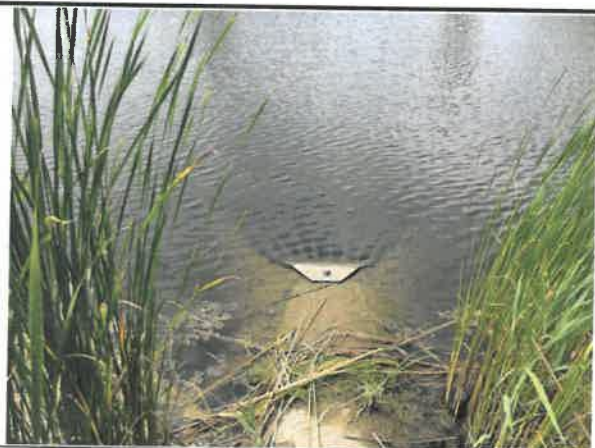
Additional comments:
Completely submerged in water

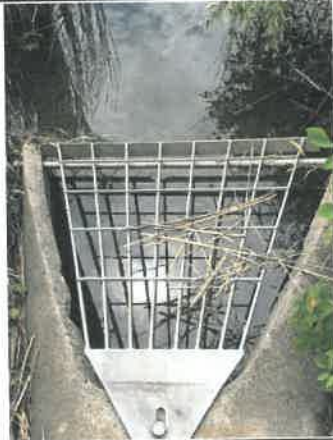
Additional comments:
Submerged in approximately 13-inches of water

Top view of outfall structure

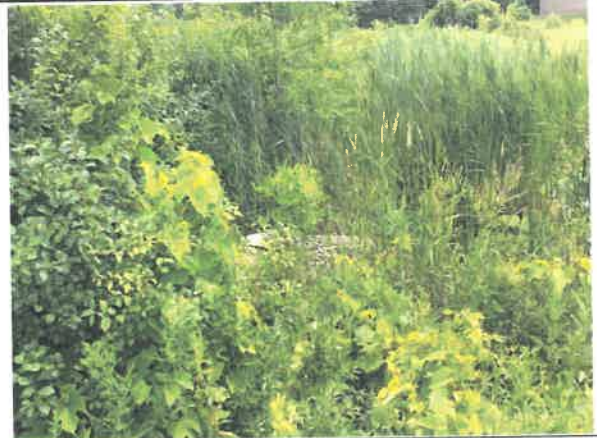
Side view of outfall structure

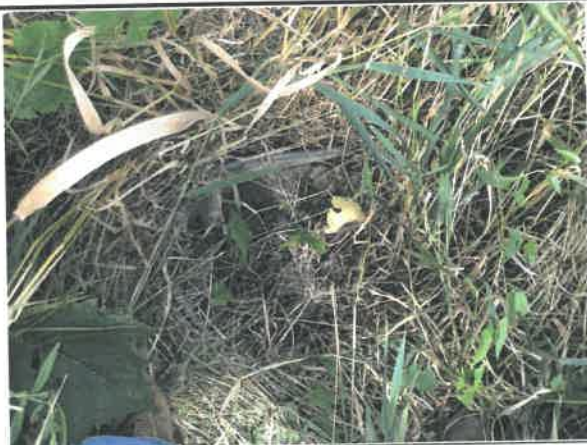
Additional comments:
Completely submerged in sediment

Outfall structure fully submerged in sediment

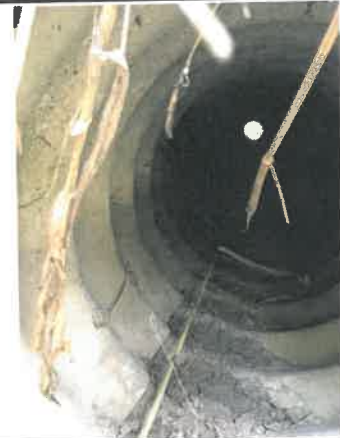
View into outfall structure

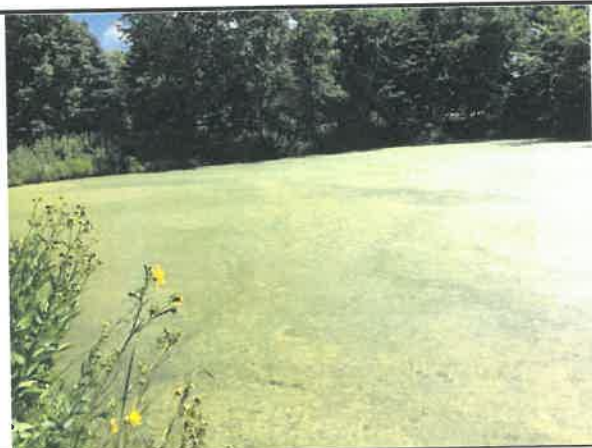
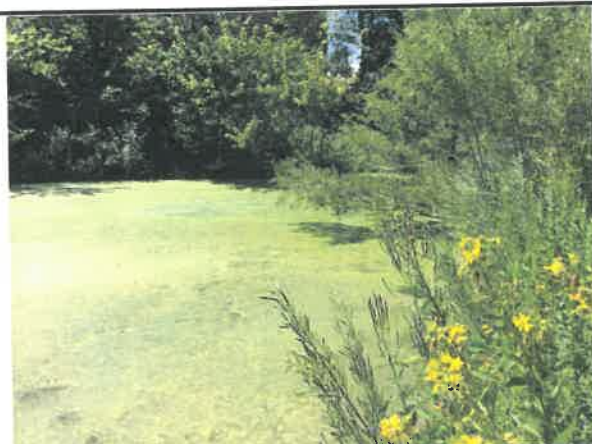
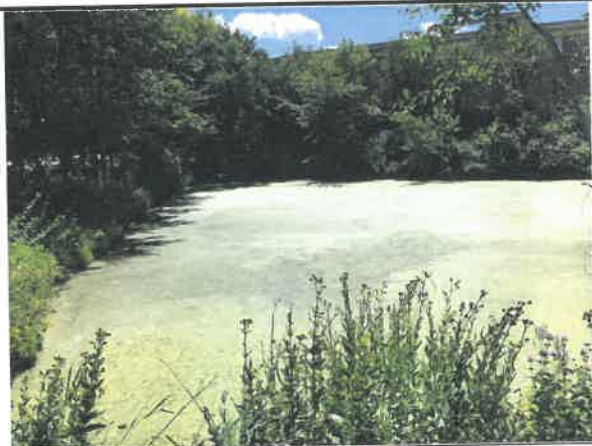
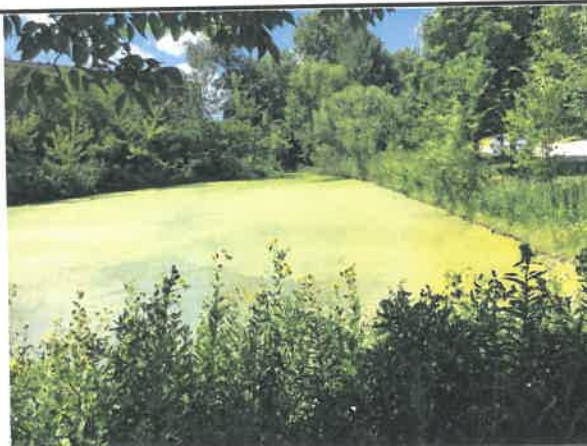
Additional comments:
Algae coverage of 100% of water surface

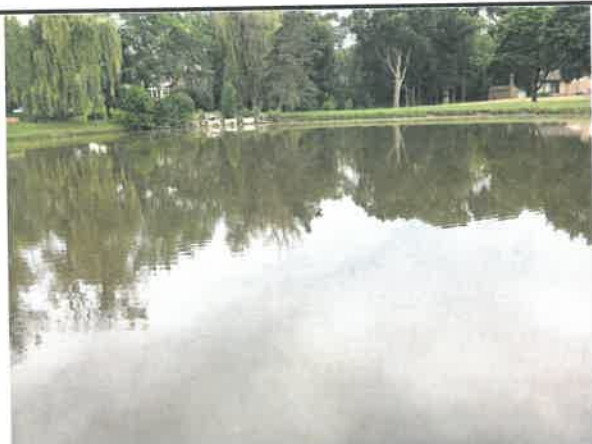
Accumulated debris located at outfall inlet structure, pool clarity poor, no vegetation observed substantial sediment observed

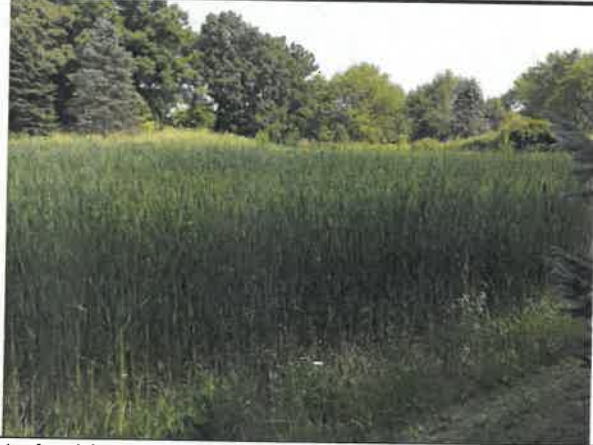
Additional comments:
Cattail vegetation covering entire basin

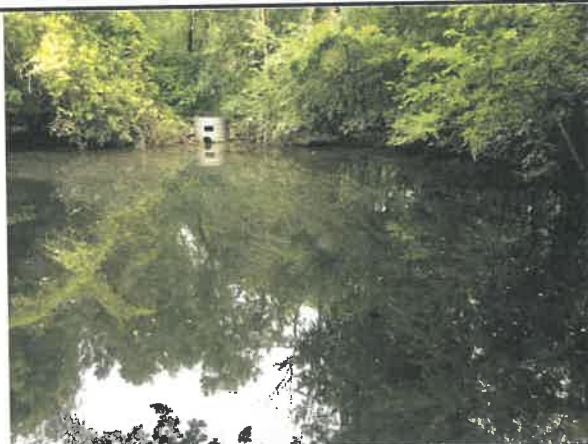
Additional comments:
Sheen on surface of water throughout basin

Sheen on surface of water

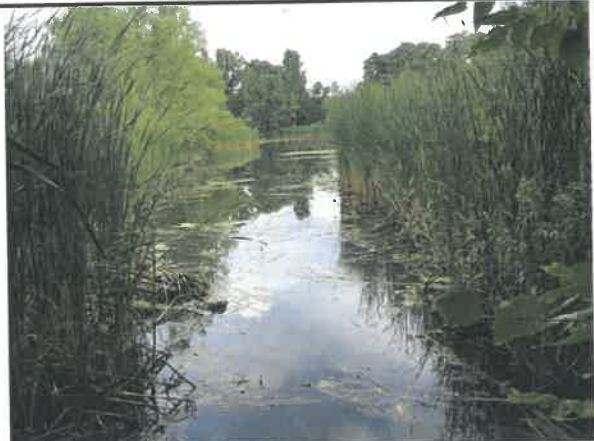
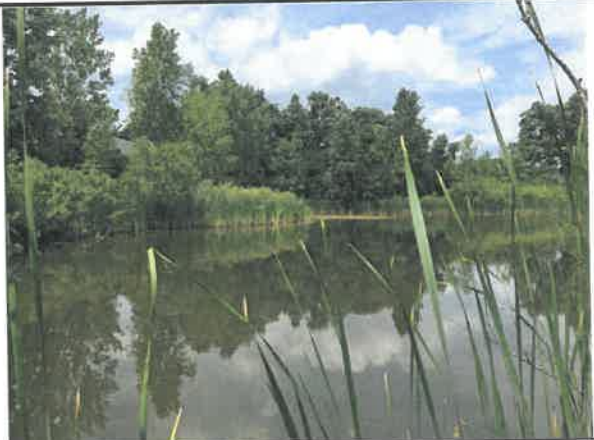
Additional comments:
Cattails surrounding perimeter of basin

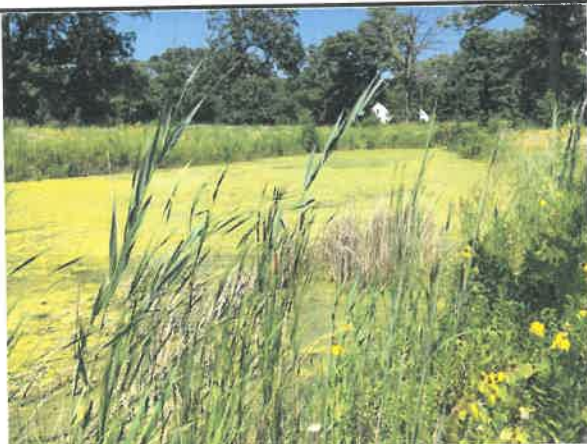
Trash or Debris Accumulated in Basin?	No	Visual Evidence of Oil, Gasoline, Contaminates or Other Pollutants?	No	Visual Evidence of Dumping?	No
Invasive or Nuisance Weeds Present?	Yes	Signs of Erosion, Staining, Damage or Obstructions at Inlets/Outlets?	No	Erosion on Side Slopes?	No
Sediment Accumulated in Basin?	No	Rock Missing Around Inlets, Outlets or Spillways?	No	Excessive Algae Present?	Yes
Evidence of Fish Kill?	No	Trash or Debris Plugging Openings in Trash Rack?	No	Maintenance Needed in Basin?	No

Additional comments:
Green algae coverage, heavily vegetated area

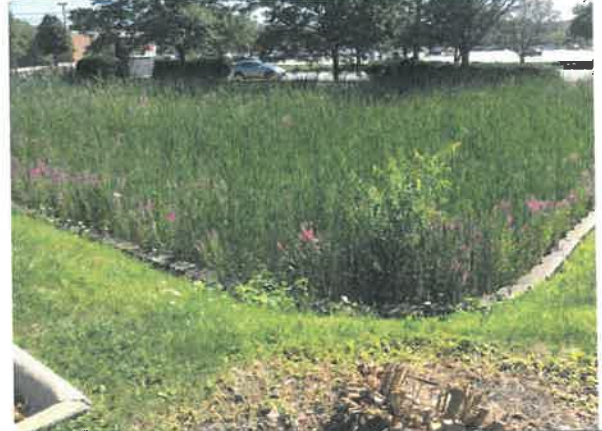
Trash or Debris Accumulated in Basin?	No	Visual Evidence of Oil, Gasoline, Contaminates or Other Pollutants?	No	Visual Evidence of Dumping?	No
Invasive or Nuisance Weeds Present?	Yes	Signs of Erosion, Staining, Damage or Obstructions at Inlets/Outlets?	No	Erosion on Side Slopes?	No
Sediment Accumulated in Basin?	No	Rock Missing Around Inlets, Outlets or Spillways?	No	Excessive Algae Present?	No
Evidence of Fish Kill?	No	Trash or Debris Plugging Openings in Trash Rack?	No	Maintenance Needed in Basin?	No

Additional comments:
Excessive quality of cattail vegetation

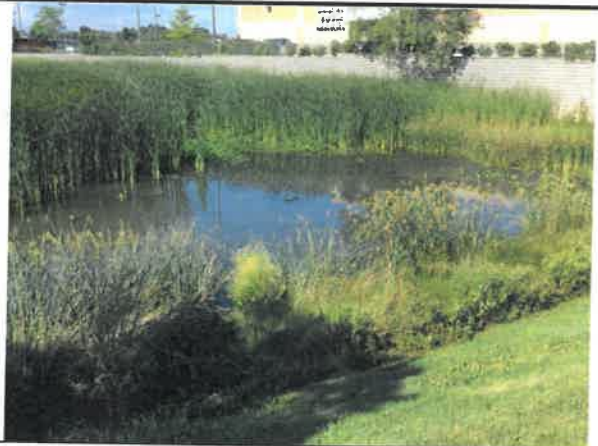
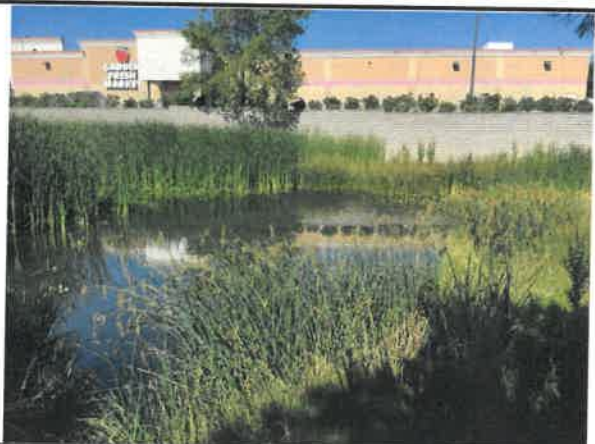
Trash or Debris Accumulated in Basin?	No	Visual Evidence of Oil, Gasoline, Contaminates or Other Pollutants?	No	Visual Evidence of Dumping?	No
Invasive or Nuisance Weeds Present?	Yes	Signs of Erosion, Staining, Damage or Obstructions at Inlets/Outlets?	No	Erosion on Side Slopes?	No
Sediment Accumulated in Basin?	No	Rock Missing Around Inlets, Outlets or Spillways?	No	Excessive Algae Present?	No
Evidence of Fish Kill?	No	Trash or Debris Plugging Openings in Trash Rack?	No	Maintenance Needed in Basin?	No

Additional comments:
Excessive quality of cattail vegetation
